Nature proves no inhibitor to concrete bridge repair

Bats, periods of prolonged persistent rainfall and fluctuating river levels were just some of the obstacles faced during the refurbishment of Clifton Bridge in York – a process that used traditional and innovative repair techniques.

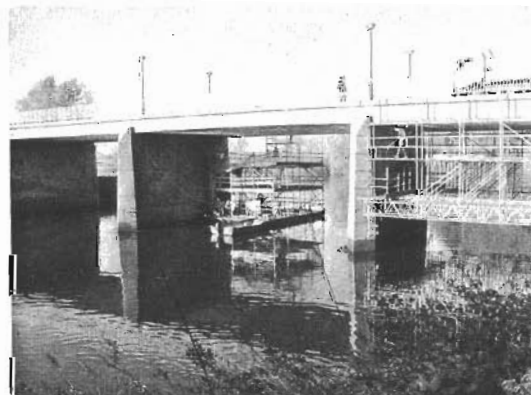
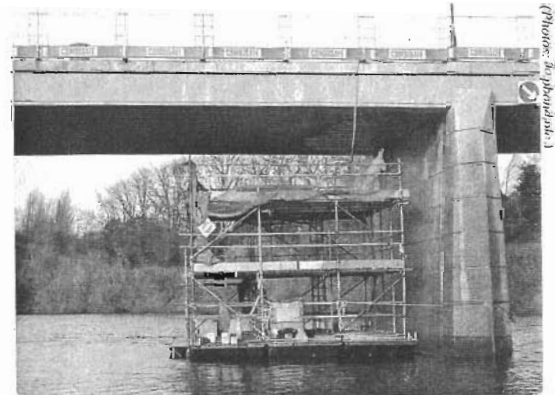
Figures 1 and 2:
The pontoons used for repair work on the RC piers.

To gain access to the structure, Topbond used birdcage scaffolding over the land spans and beamed over the riverbank spans taking support off the piers. For the river span, birdcage scaffolding – with cantilevered walkways along the side giving access to the piers – was built off Topbond's floating steel pontoon. Warning signs were installed upstream and downstream of the bridge to advise the river users of the work and Topbond was in close contact with the operator of local river sightseeing cruisers.

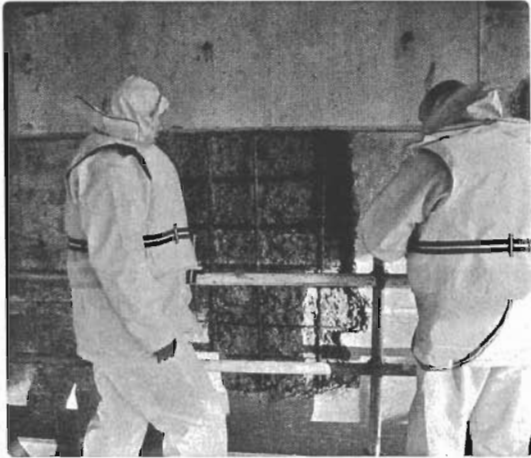
Figure 3 far left: Reviewing the concrete removed by water jetting.

significant areas of hollow-sounding concrete were found in the river piers. In these areas concrete removal was undertaken using high-pressure water jetting and then, after grit-blasting, the concrete was reinstated using approximately 10 tonnes of SikaCem 133 Gunite.

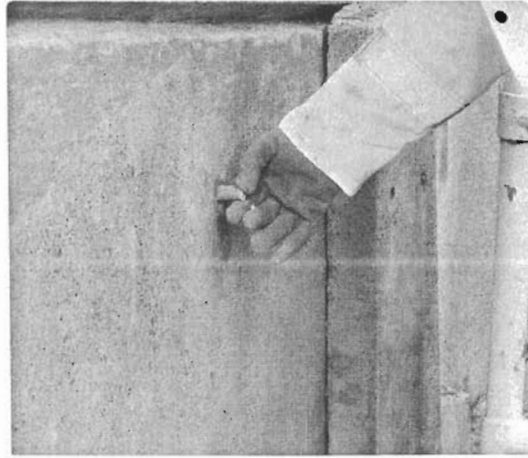
Figure 4 left: Installation of the Margel cartridge system.

To protect the steel reinforcement in the precast and in-situ elements of the bridge, the client wanted the further protection offered by migrating corrosion inhibitors. As an approved installer of QED's system, Topbond installed approximately 5000 Margel DCI 580T microporous cartridges containing the blended components of migrating vapour phased corrosion inhibitors (MVPCIs or VPIs for short) offering fast medium- and long-term protection. Each cartridge was installed in a 20mm-diameter hole at a depth of 100mm below the concrete surface, covered with a compressible disk and then sealed in place with a repair mortar. This has the advantage of placing the material at the depth of reinforcement, allowing the cartridges to offer immediate protection to the steel reinforcement. The Clifton Bridge contract is to-date the largest bridge refurbishment contract to use QED's Margel cartridges.

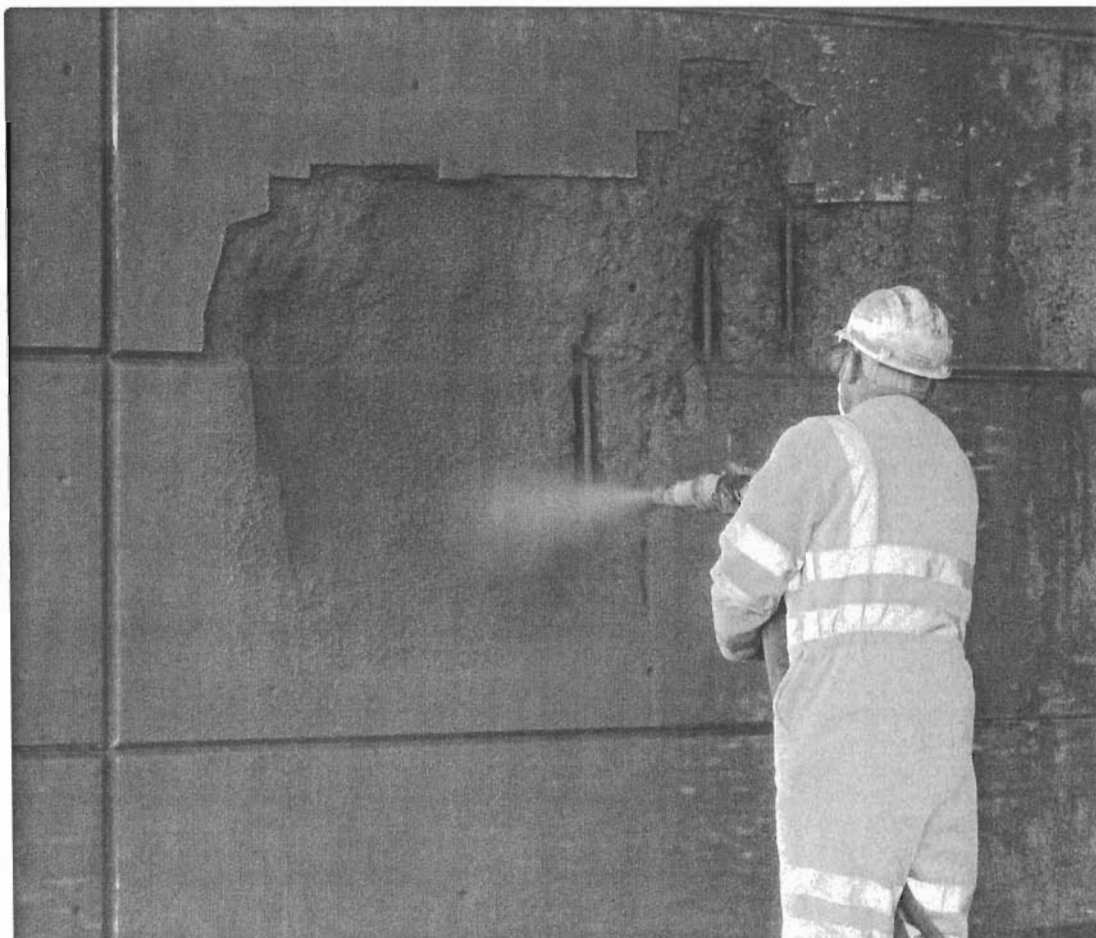
Figure 5: Application of sprayed concrete.
